# Test report

Our claim number **R0085/10** HEPU - reference: **P980**  
Your claim number **1937493** Your reference: **1420-P980**

Vehicle: **Volvo V70** Engine: **2.4 ltr.**  
Date part fitted: **22 August 2008** mileage when fitted: **182059**  
Date part removed: **12 February 2010** mileage when failed: **331532**  
Days of mounting: **530** complete mileage: **149473**  
Production date of the waterpump: **01 October 2007** Reason for returning: **bearing failure**

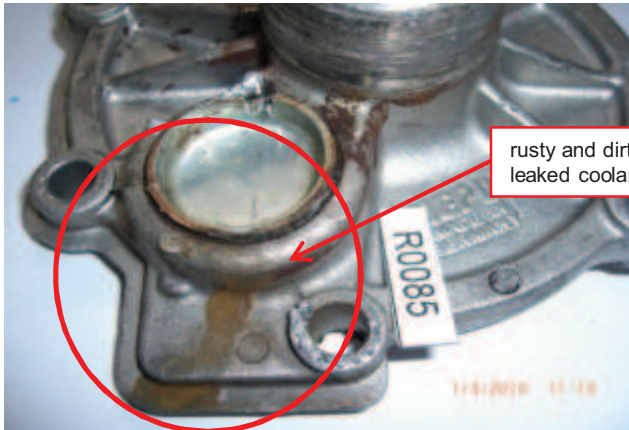
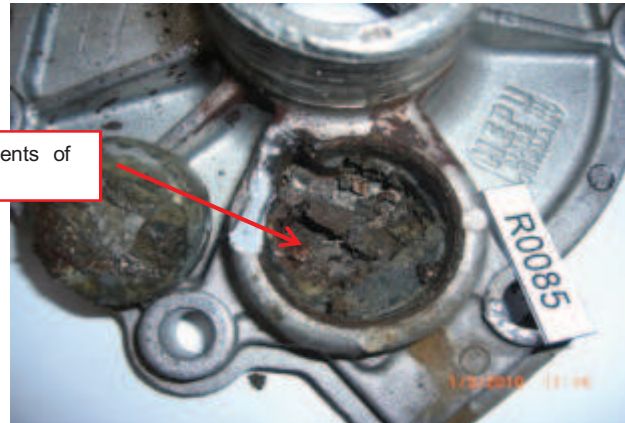
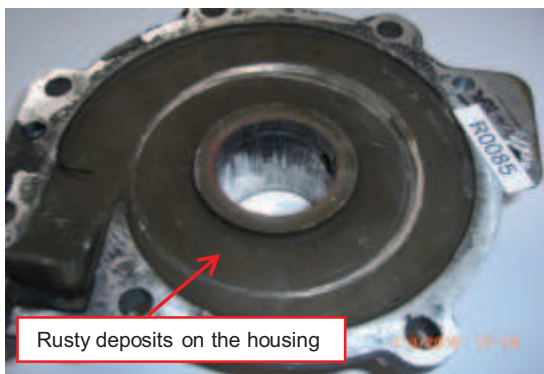
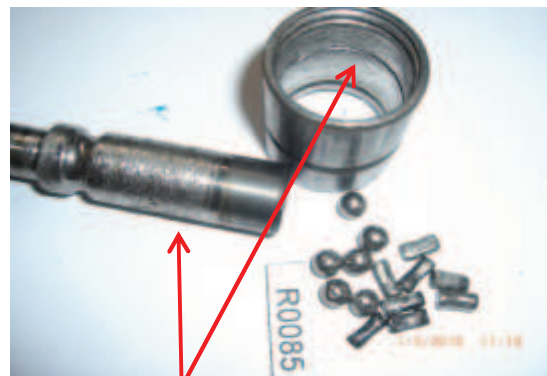
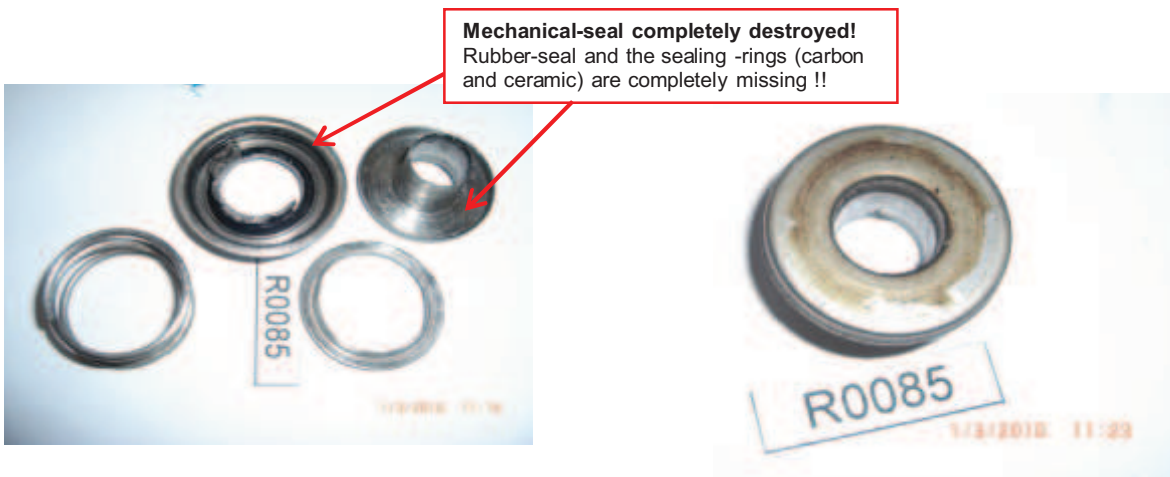
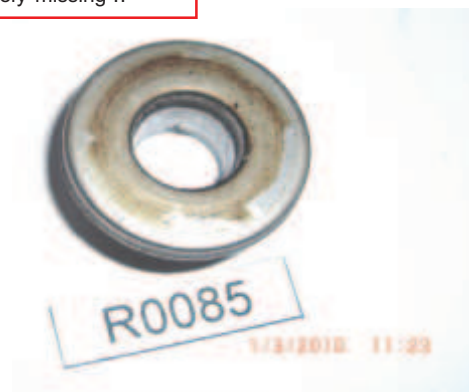
Pictures

Reason of the claim: **dirty fluid**

An examination of the pump did not reveal any material or manufacturing error. The bearing and seal are completely destroyed. The body rusty sediments contaminated coolant can be seen. Reason of the bearing failure is dirty and rusty fluid in the cooling circulation. First the pump became leak by rusty and dirty fluid. You can see the dirt and rust on the added pictures. The small particles of rust and dirt have grinded the karbon- and ceramiking of the mechanical-seal so strong, that they became leak. This leakage was the reason, that the water was able to come into the bearing, cause the rubber-seals of them are only against stuff and not against fluid. Between water and grease it comes to an emulsion. Lubrication stops and the bearing is broken. In this case, the mechanical seal is completely destroyed. The rubber seal and the seal rings are completely missing. This shows that the pump has not been changed despite the strong leakage and the loudly noises!

**COMMENT:** As demonstrated by the very strong destruction of the bearing and the mechanical-seal, had the engine failure can be avoided. The collapse of the bearing has made at least 1000 - 1500 km noticeable before the engine damage had entered by loud noises from the timing-belt and significant water loss. Through the timely consideration of this indication the engine failure would have been avoided.
